CRUISE REPORT

R/V Aranda

Cruise 06/2023

HYLYT

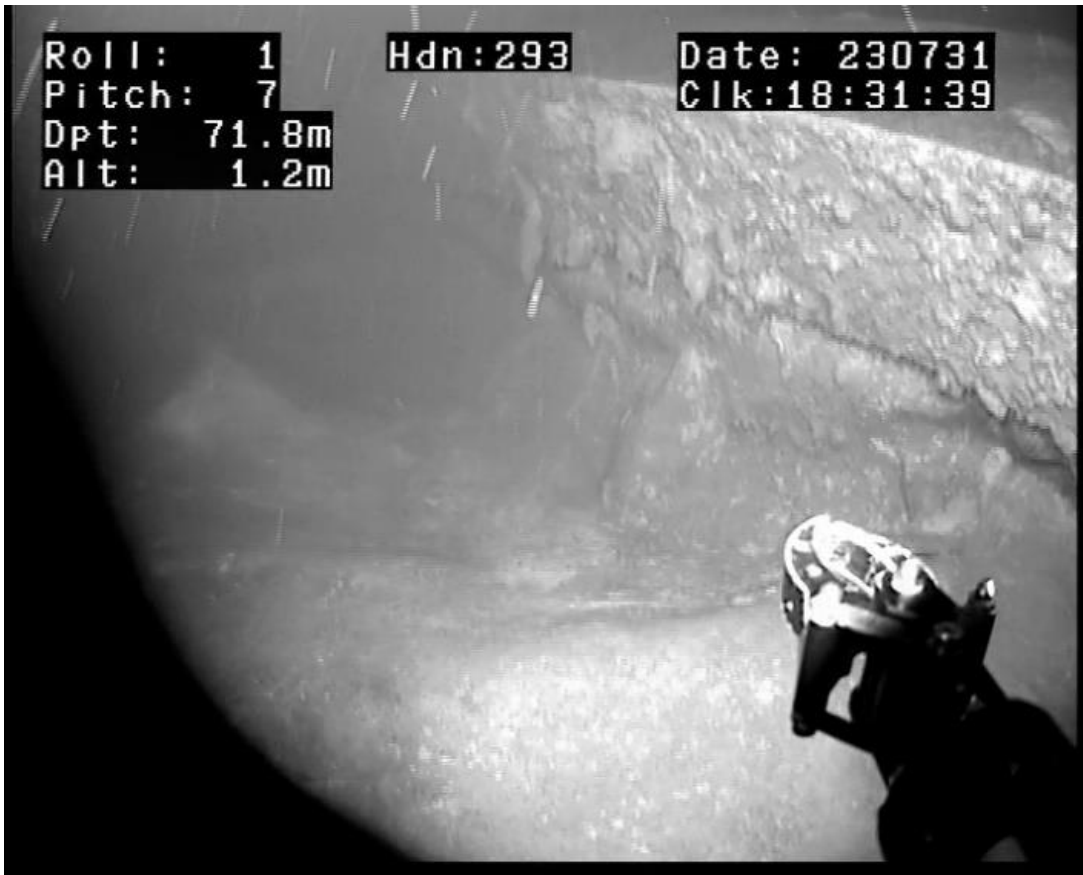
Corrosion in the wreck of Ilmarinen seems substantial and is likely to continue, posing a risk to larger oil leak from fuel tanks right below hull exterior surface. Bottom section of hull seems intact and therefore tanks also are intact. The observed oil leak is small but constant. However, based on the water samples, the leak has not compromised local water quality yet.

Annex 1. Screenshots of ROV footage: (upper image) depression around midships and (lower image) fracture close to ship's bow section (Finnish border guard).

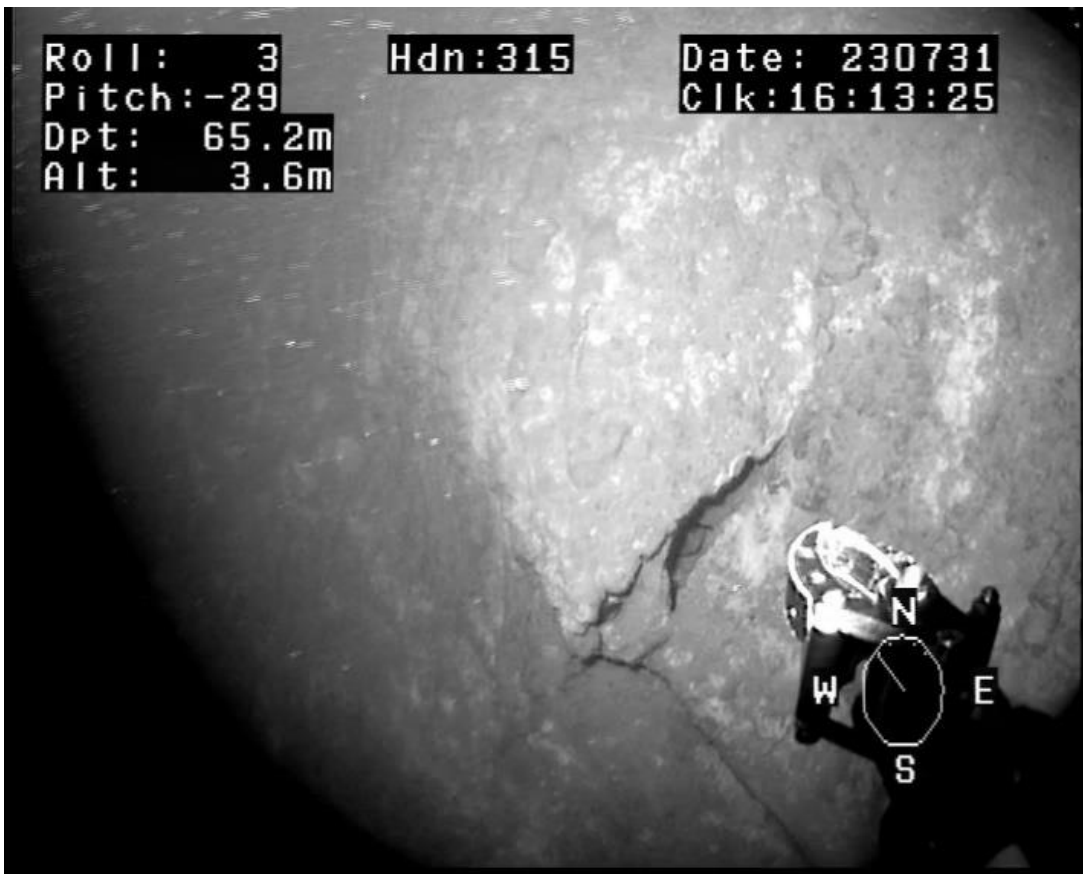
There was no observable change in overall angle or sediment burial of the wreck compared to hydroacoustic data from 2021. Ghost nets with unknown (wooden?) object inside one net surrounding anchors and adjacent sections of hull were documented. A fracture in hull exterior potentially close to one fuel tank area was observed. Based on ROV video footage and MBES data, there is a several-meter-long depression in hull close to wreck's original waterline. In general fuel tank sections over the seafloor appear intact. Oil leak from the battleship occurred but was not seen in underwater video footage. Notable corrosion around the wreck hull with local depressions was evident. Of fuel tanks of the wreck at least 12 can be accessed from above while the remaining three are at least partially buried inside soft sediment in wreck aft section. Sediment cores reflected sporadically oxic and anoxic conditions near seafloor level. Current deep water was oxic. There was no indication of oil in water samples based on fluorometric monitoring method. Hydroacoustic data on Huis Te Warmelo and its vicinity was of adequate quality. The main observations regarding the battleship Ilmarinen were presented in a media event in Helsinki on the afternoon of August 4.

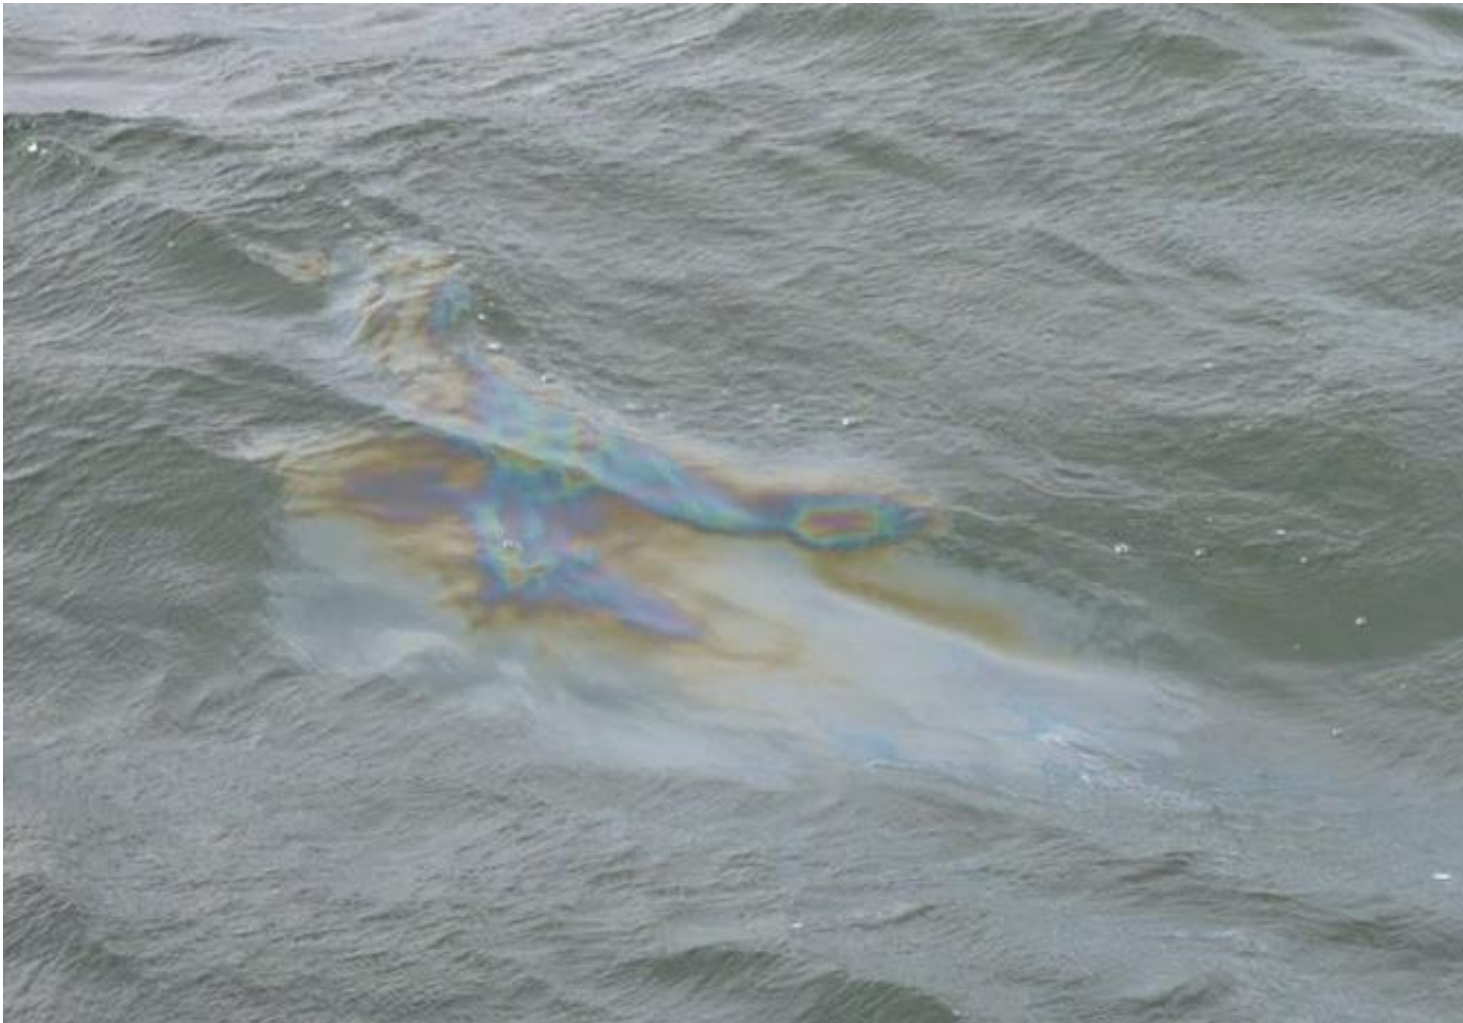
Annex 2. Oil slick on top of the wreck (Miia Farstad, Syke).

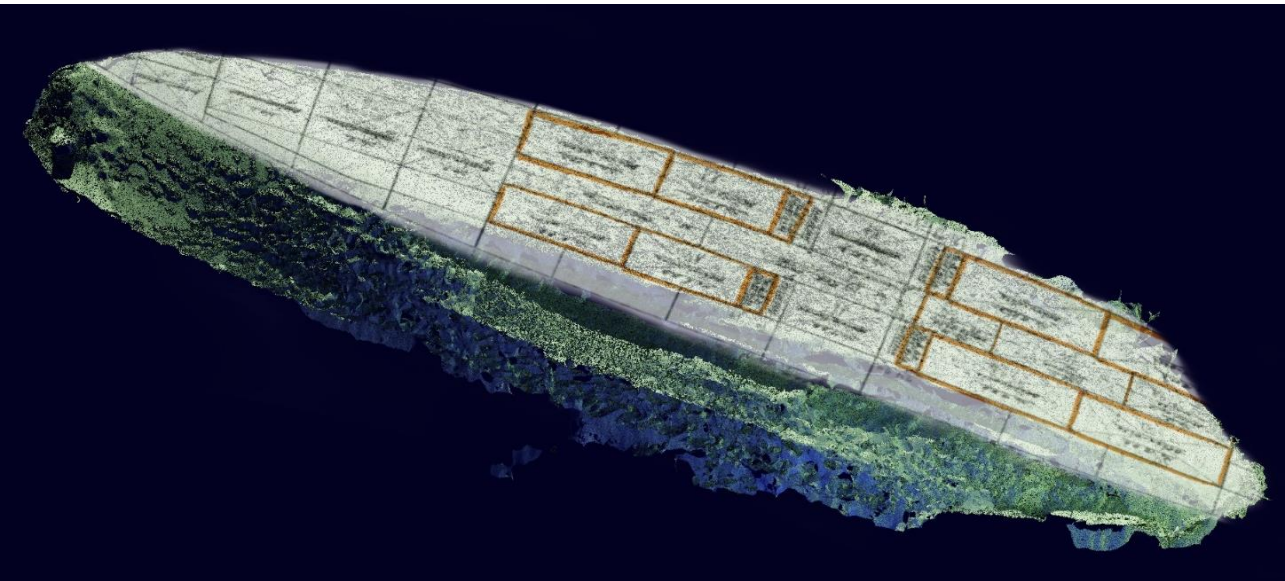
Annex 3. Schematic view of fuel tank sections overlaid on 3D mesh of battleship Ilmarinen (Syke & Finnish border guard).
